# Potential causes of disk-brake friction : page 1

# Potential causes of disk-brake friction : page 2

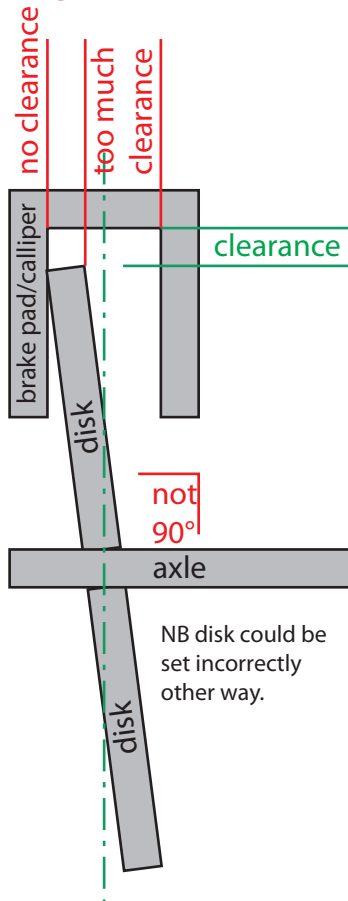
## 3: disk at angle to axle

once-per-revolution friction

disk is 'flat' and has uniform thickness

In cases of once-per-revolution friction, both the brake and disk should be replaced because both will have suffered more wear than should have occurred and because disk is likely to be poorly manufactured.

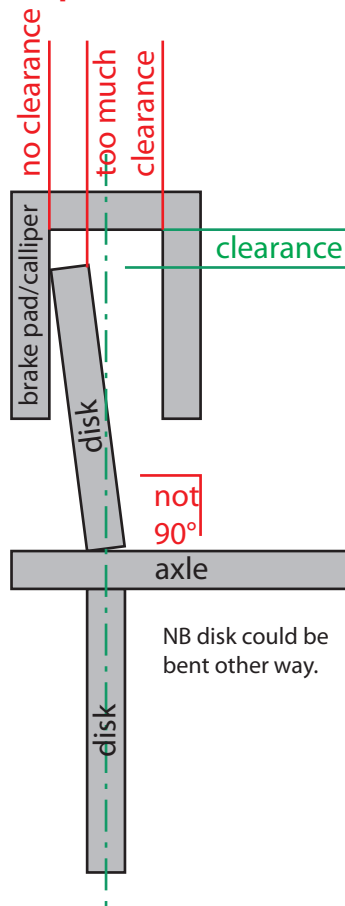
## 1: disk not flat

once-per-revolution friction

disk is not 'flat' but still has uniform thickness

NB disk could be bent other way.

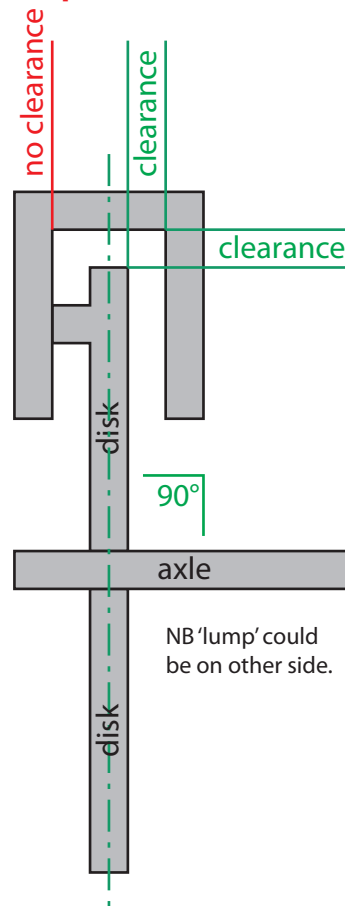
## 2: disk not uniform

once-per-revolution friction

disk is flat but does not have uniform thickness

NB 'lump' could be on other side.

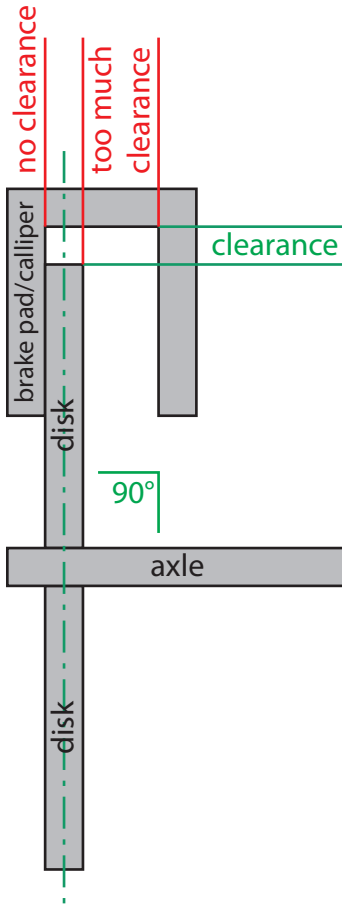
## 4: disk in wrong place on axle CONSTANT friction

disk is 'flat' and has uniform thickness

In cases of constant friction, both the brake and disk should be replaced because both will have suffered more wear than should have occurred.

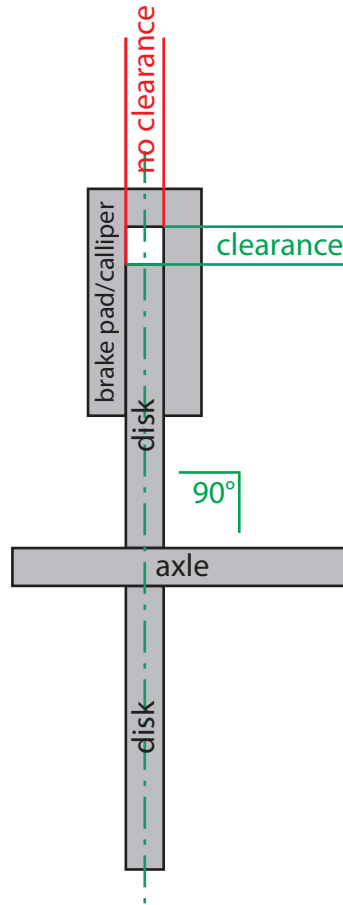
## 5: brake too narrow CONSTANT friction

disk is 'flat' and has uniform thickness

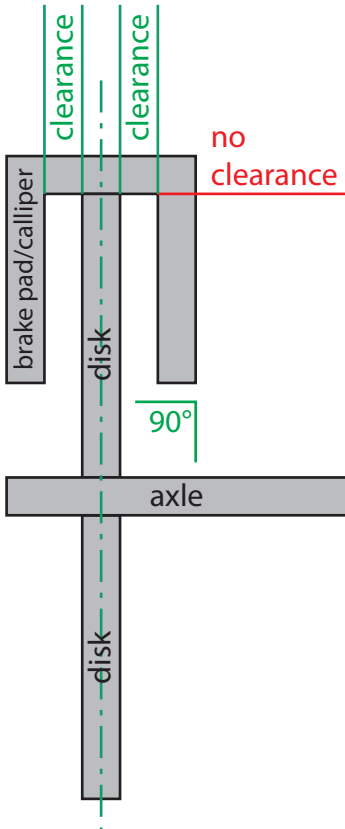
## 6: brake too low CONSTANT friction

disk is 'flat' and has uniform thickness

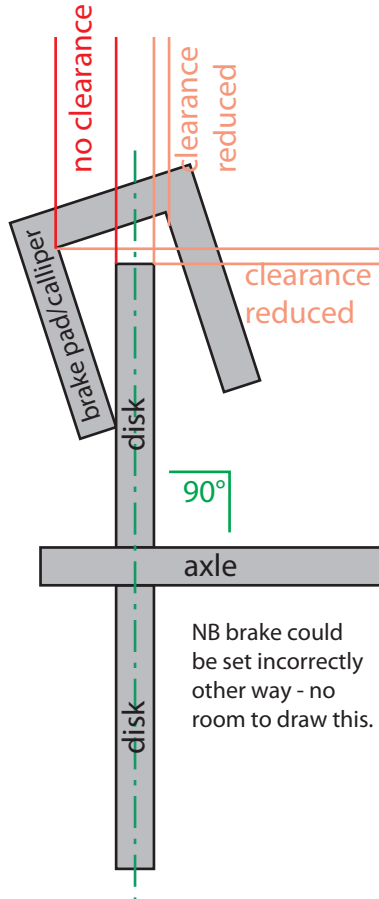
## 7: brake at angle CONSTANT friction

disk is 'flat' and has uniform thickness

NB brake could be set incorrectly other way - no room to draw this.

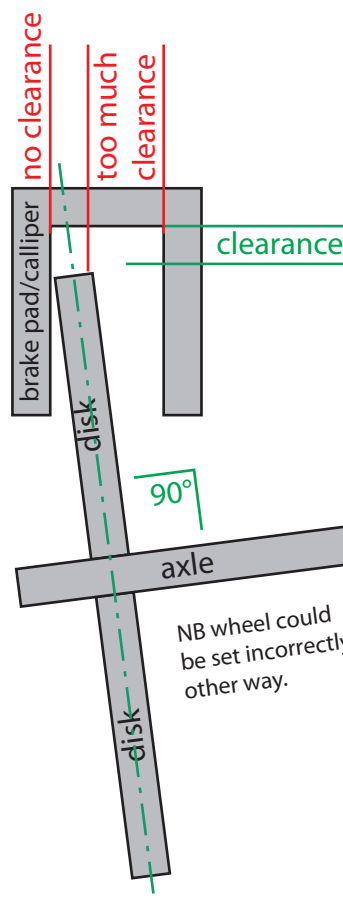
## 8: wheel set at angle CONSTANT friction

disk is 'flat' and has uniform thickness

NB wheel could be set incorrectly other way.
